Memo

Project: 0013091150

Subject: Hazardous Conditions Response Plan – Crusher Road Slope Instability

CRUSHER ROAD SLOPE INSTABILITY
Leviathan Mine Site
Alpine County, California

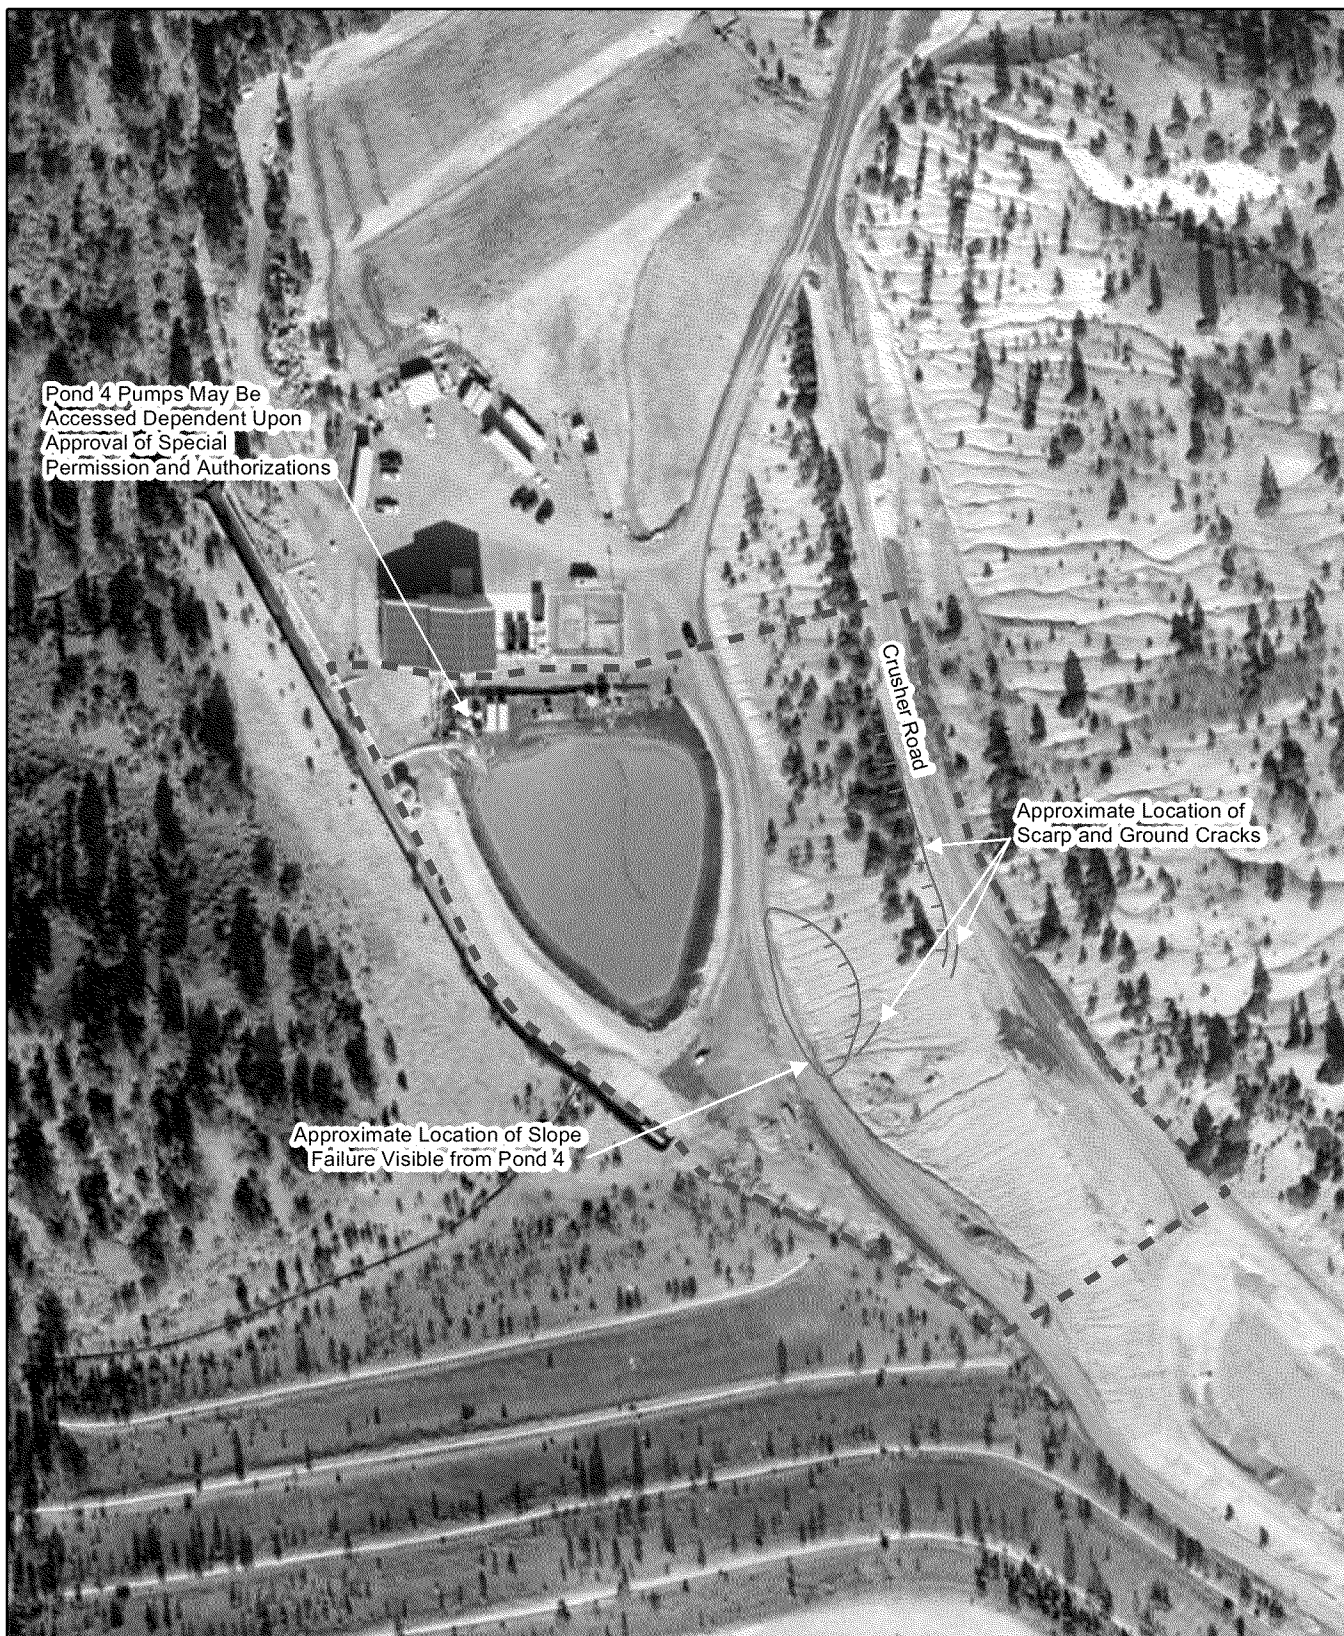
Figure
1

The area of the slope movement is located east of Pond 4, on the uphill slope immediately below the “Crusher Road” and is referred to herein as the Crusher Road Slope Instability. The upper limit (head) is defined by an approximately 200-foot-long zone of tension cracks and scarps located along the west edge of the Crusher Road. The lower limit (toe) is at the base of the slope east of the main site road adjacent to Pond 4, and extends out into the main access road near the southern end of Pond 4. The northern extent of the visible ground cracking is east of the approximate northern end of Pond 4. The southern extent of visible deformation features is approximately 50 feet south of southern edge of Pond 4. The approximate location of the tension cracks, scarps, and slump area of the Crusher Road Slope Instability are shown in Figure 1. Photographs that show site conditions April 28, 2017 and May 2, 2017 are provided in Appendix A.

The exclusion zone is shown on Figure 1.

This memorandum establishes an exclusion zone in the vicinity of the Crusher Road Slope Instability. The purpose of this exclusion zone is to minimize the potential hazard exposure to personnel. It is not intended to control possible damage to infrastructure.

Barriers have been placed on the road adjacent to Pond 4 to demarcate the north and south ends of the exclusion zone. Similar barriers were installed on the Crusher Road north of the northern extent of the Crusher Road Slope Instability.

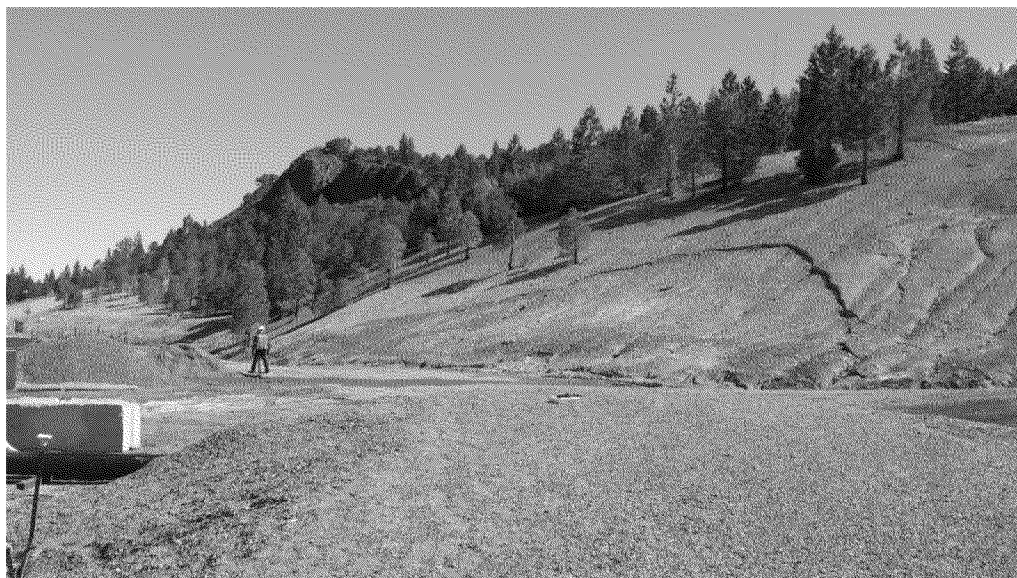
- A subordinate slope deformation defined by scarps in an arcuate feature in the lower portion of the slope immediately east of the main site road adjacent to the south end of Pond 4.
- A toe bulge in the main site road adjacent to the southern portion of Pond 4.

Photograph A1: Arcuate shaped scarp outlining subordinate failure on lower portion of Crusher Road slope. View looking north. Photo taken April 28, 2017.

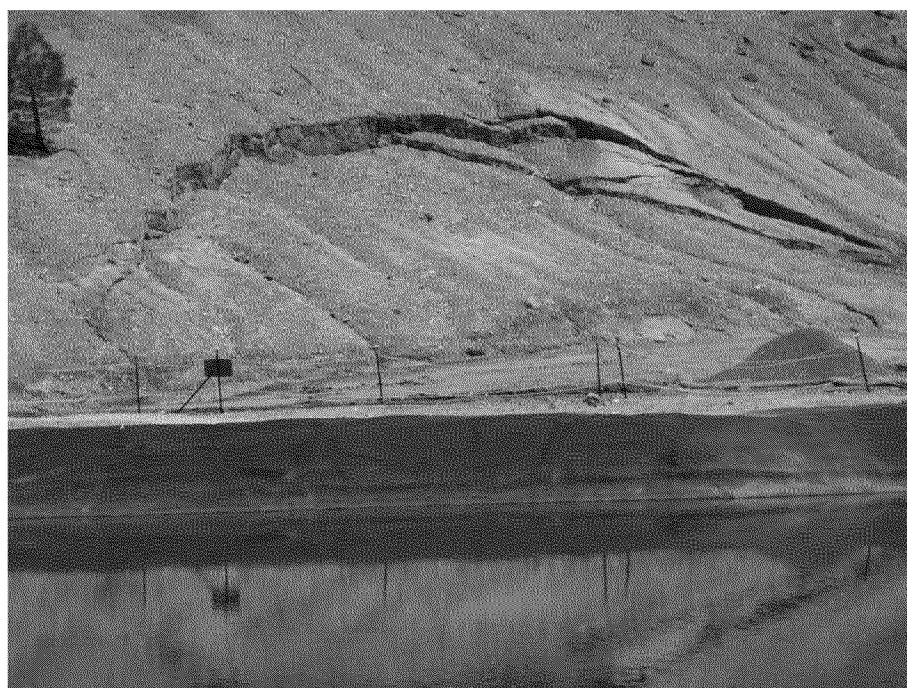
Photograph A2: Arcuate shaped scarp outlining subordinated failure on lower portion of Crusher Road Slope. View looking southeast. Photo taken May 2, 2017.

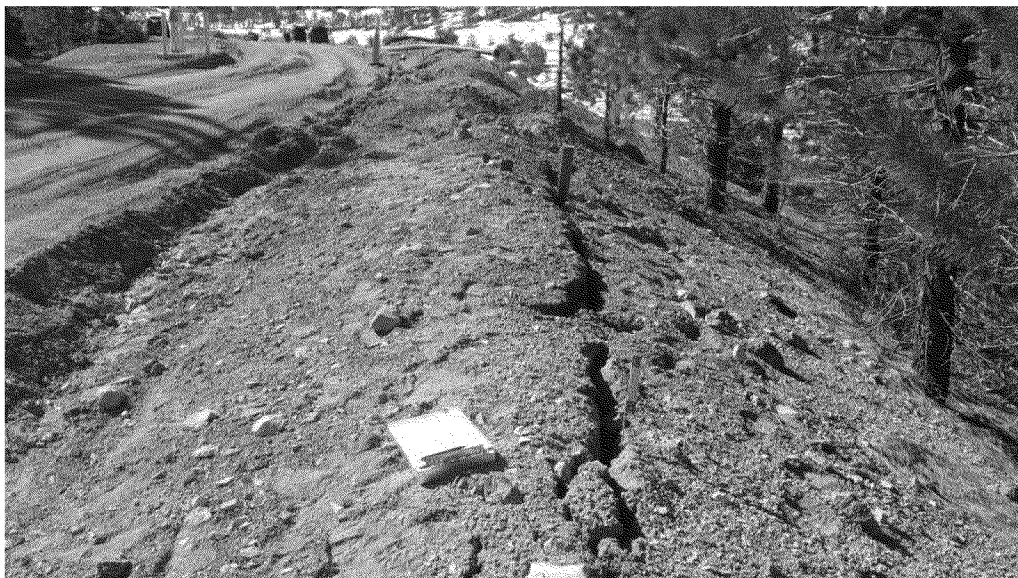
- Tension cracks (ground cracks with no vertical offset) and scarps (ground cracks with vertical offset) along the west side of the Crusher Road.

Photograph A3: Scarp forming at top of Crusher Road slope. View looking south. Photo taken April 28, 2017.

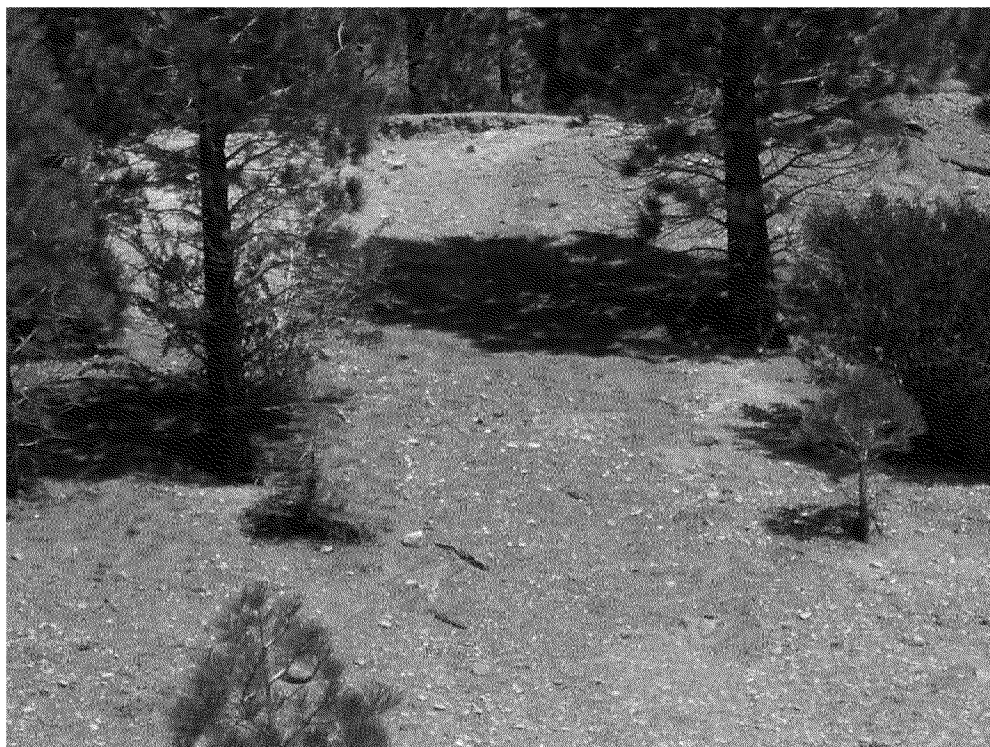
Photograph A4: Scarp forming at top of Crusher Road slope. View looking East. Photo taken May 2, 2017.
